BUILDING LIMES FORUM ANNUAL CONFERENCE & GATHERING BELFAST 2022

5 Northumberland Road, Dublin 4 A former parochial house built in 1899

Conservation & Restoration of Historic Mortars

A Question of Conservation or Restoration

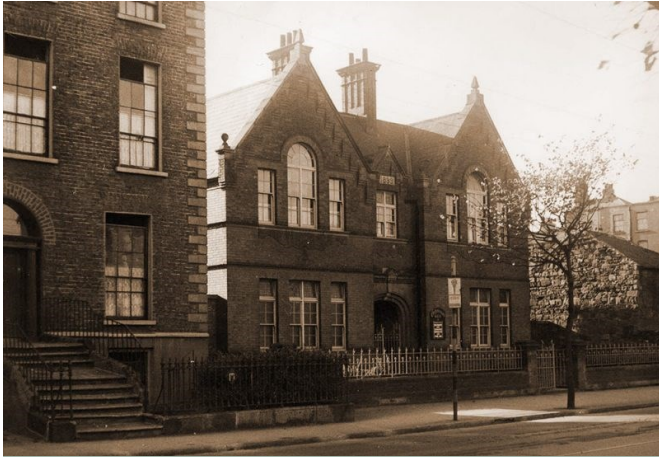
Archive image of No.5 Northumberland Road.

Over 100 years of traffic and pollution led to the deterioration of this beautiful brick façade at the top of Northumberland Road. The introduction of cementitious mortar pointing and damaged rain water goods caused further damage to the façade leaving it in a very fatigued state. Bricks were spalled and parts of the granite sills and window surrounds were missing. The chimneys were overtaken with Buddleia growth leading to the ingress of water which is very common in Dublin, were this hardy plant can be observed on most roof tops.

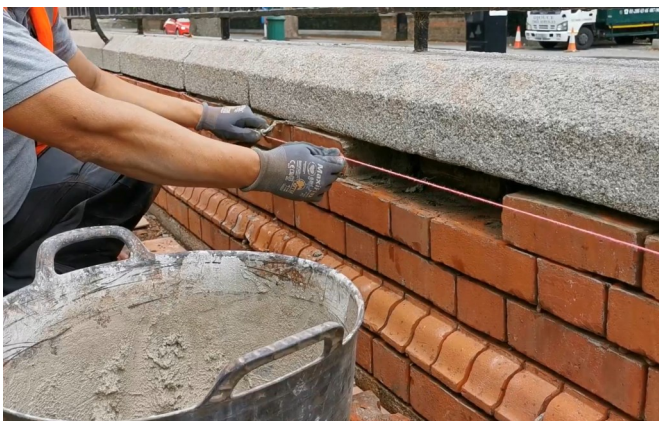
Replacement of irreparably damaged brick.

It also features ornate granite capping, parapet and pillars. Parts of these features had broken and chipped and needed to be repaired. Damaged and missing bricks were replaced where possible with matching salvaged bricks. Some spalled bricks were repaired using pigmented St Astier lime mortar from the Traditional Lime Co.

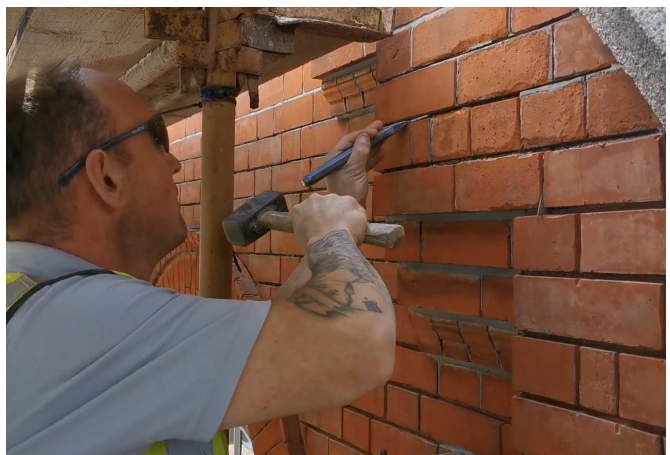
Raking out of inappropriate cement-based mortars.

All cement mortar had to be cut out from the joints using hand tools and fully cleaned out. The joints were then repointed using NHL lime mortar in the original flush style. Lime pointing allows the building to breathe again through the joints, not forcing water through the bricks which was causing the bricks to spall.

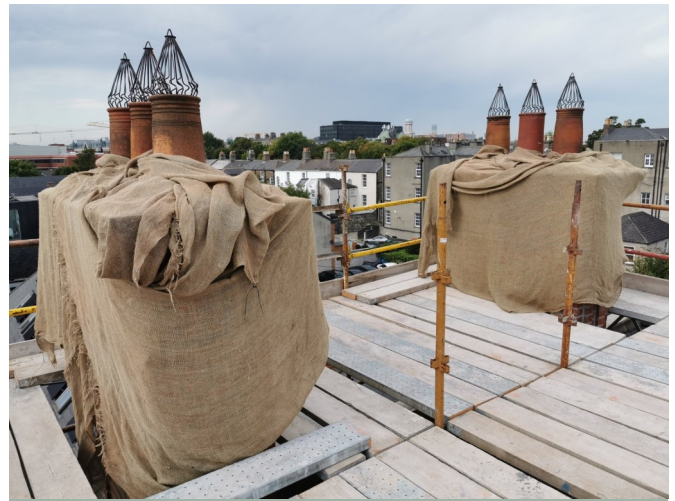
Protection of lime works to chimney stacks.

The two stacks were in bad shape and it was sad to see such decorative brickwork fall into disrepair. Buddleia is an invasive species and their seeds are dispersed by wind and find their way into damaged brickwork or cracks in mortar and overtime the strong roots embed themselves within cavities and put pressure on the structure allowing wider cracks to form which leads to further damage. The roots of the Buddleia were treated with a herbicide to ensure the growth would not return after our restoration. The chimneys were dismantled brick by brick and numbered. Some of the intricate brick specials needed to be replaced so we sourced suitable salvage bricks and they were rubbed to create a matching shape. We then rebuilt the stacks and re-haunched the caps using lime mortar and now they stand proud and strong again.

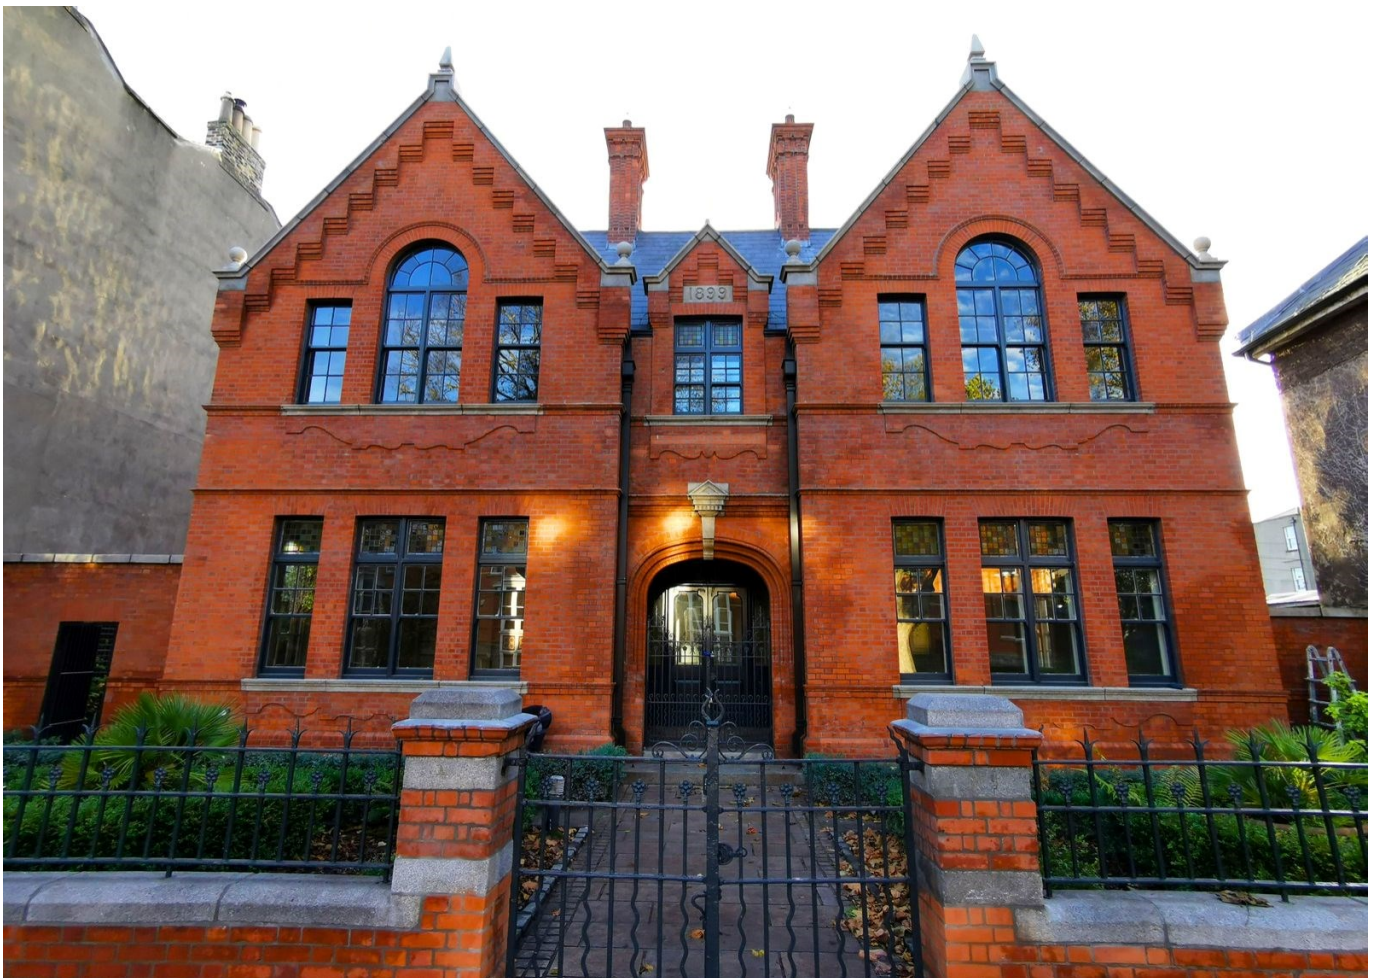
No.5 Northumberland Road on completion of works.

The result of the restoration works are stunning and we are delighted once again to have played our part in restoring this beautiful piece of our built heritage on this architecturally significant street.

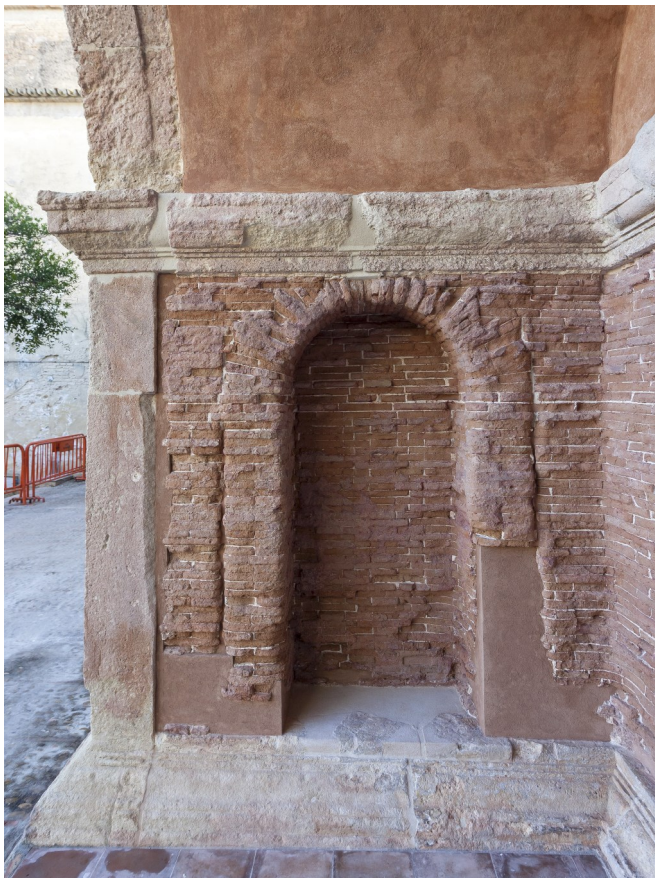
Volume reintegration in the most damaged areas of the brick fabric with lime putty mortar.

Since the information about the decorative finish of the carved brick fabric was not clear, to avoid conjecture, it was decided to reintegrate harmoniously in low level using a mortar with texture and color similar to the damaged fabric. In this case we try to keep the attention on the historical fabric, maintaining an overall vision and avoiding focusing on the new reintegration elements. For this mortar it was used a mix of brick dust, marble sand (to improve grading curve), iron oxide pigments and lime putty.

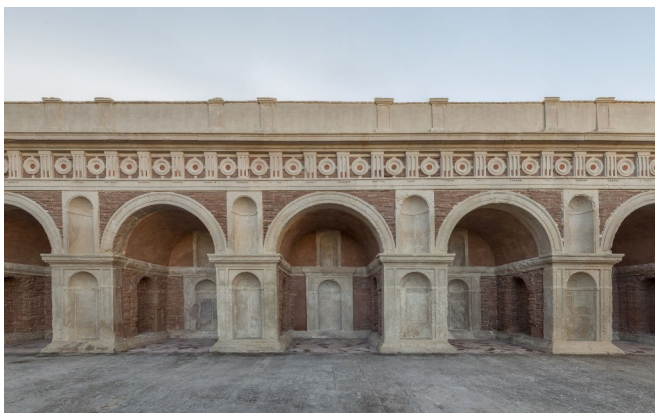
Renaissance "loggia" on completion of works.

In this monument it was also necessary to cover the renders that were inside the vaults, so after cleaning, it was applied a shelter coat (lime putty-marble powder) and over this, some translucent patinas with mix of pigments and lime putty to harmonise with the bricks fabric. For the render of the parapet, it was used the same painting process but using a higher percentage of lime putty in the mix of pigments, so after drying, it is still vibrant color surface but

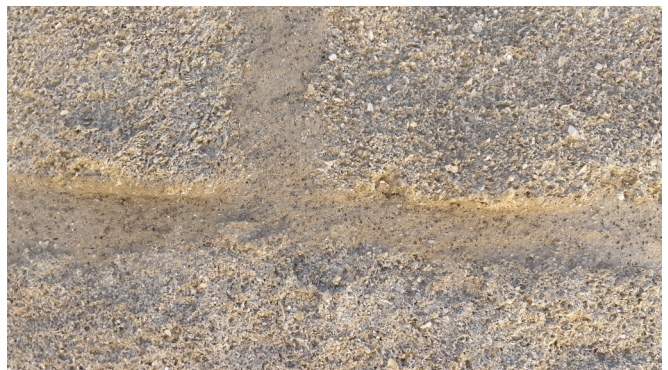
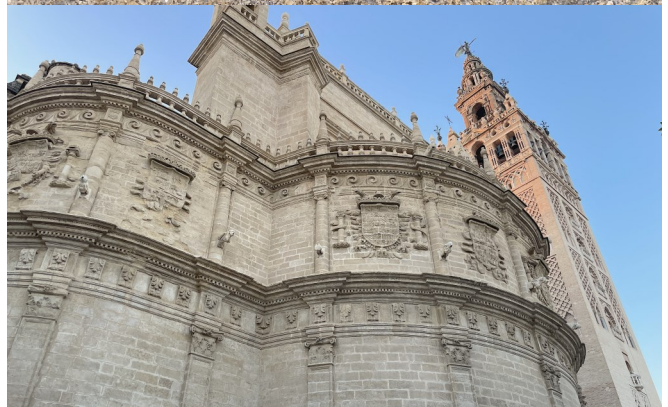
Top image: Detail of the surface of the stone and new re-pointing. Bottom image: Seville Cathedral.

During the works carried out on the Renaissance façades of the Cathedral of Seville, a similar procedure was performed with the mortar for pointing the stone, matching in texture and color to the stone ashlar, not the joints. Due to the weathering of this type of calcarenite stone over the years, sometimes the mortar has to fill a larger area around the joint. For this mortar, a hydraulic lime prepared by the manufacturer was used. It was given to the manufacturer a recipe based on this powdered lime, pigments, marble sands and two types of quartz sands of angular morphology, which, in addition to obtaining a good structure, manages to match the texture and color of the calcarenite stone. Thanks to this recipe, the lime manufacturer could deliver the number of pallets required to finish the works as a pre-dosed mortar. In other areas, it was created other recipes for compatible pointing mortars matching the historic pointing, not the stones, in color and texture.

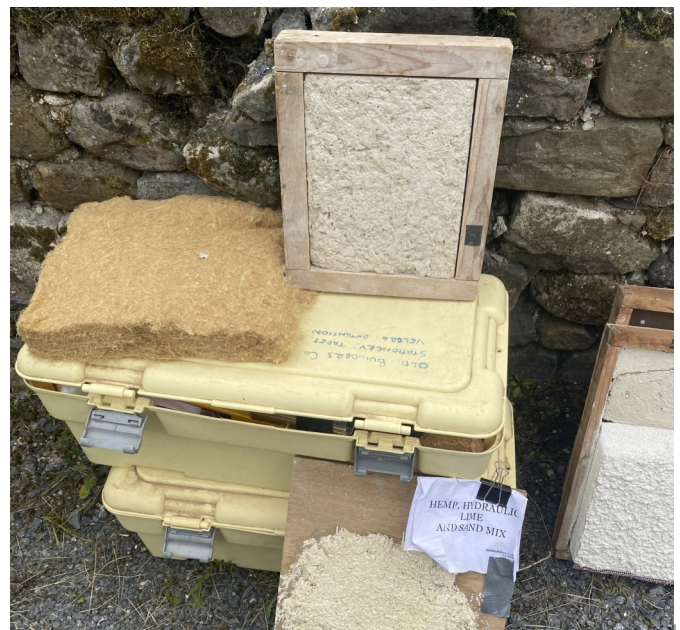
Sample products including hemp and lime based plaster.

During the lunch and coffee breaks, the attendees were encouraged to view the exhibits of a broad range of commercially available materials from which to create traditional mortars, plasters and renders, in addition to the lightweight additives that can improve their thermal performance.

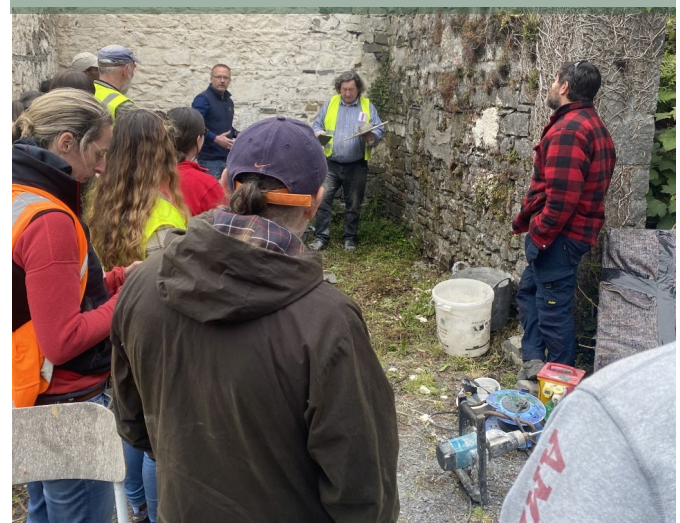
Henry Thompson (BLFI Board Member) demonstrating the application of insulating lime renders.

After lunch, served up by our hosts at Shankill Castle, the focus of the demonstrations shifted to the use of contemporary insulating renders, and how to achieve better thermal performance without compromising the vapour permeability or dewpoint in a traditional solid masonry wall. Demonstrations of a variety of types of renders with additives ranging from chopped hemp, ground cork, diathonite and other lightweight materials were given by expert practitioners Henry Thompson and Brian Tobin, and supplier Niall Crosson, from Ecological Building Systems.

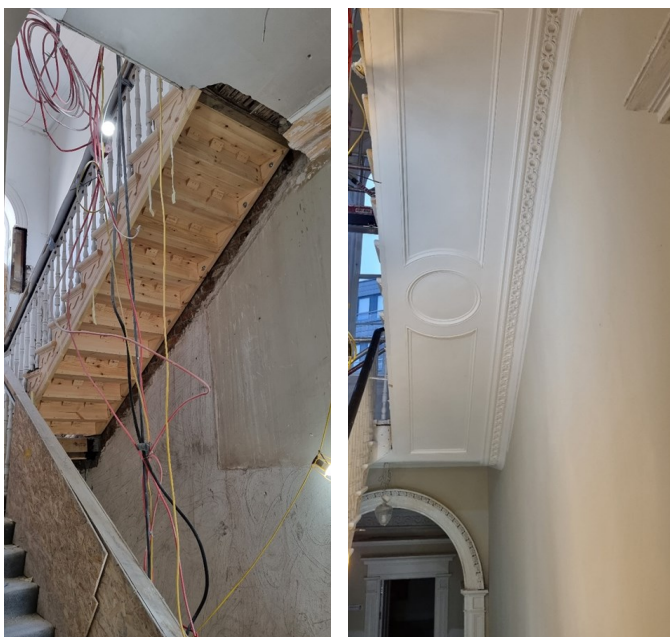
Undercarriage of staircase before and after restoration.

At Wilton Place we retained as much of the historic plasterwork as possible choosing to restore the scheme back to its former glory - the way it was originally intended using historically appropriate techniques and materials. While we always aim to retain as much of the historic fabric as possible the colonisation of dry rot in areas of the building necessitated the removal of substantial areas of plasterwork, not least of all in the stair hall where two flights of the staircase had to be carefully taken down. In these areas we restored the decorative registers to the undercarriage of the staircase once this had been reinstated.

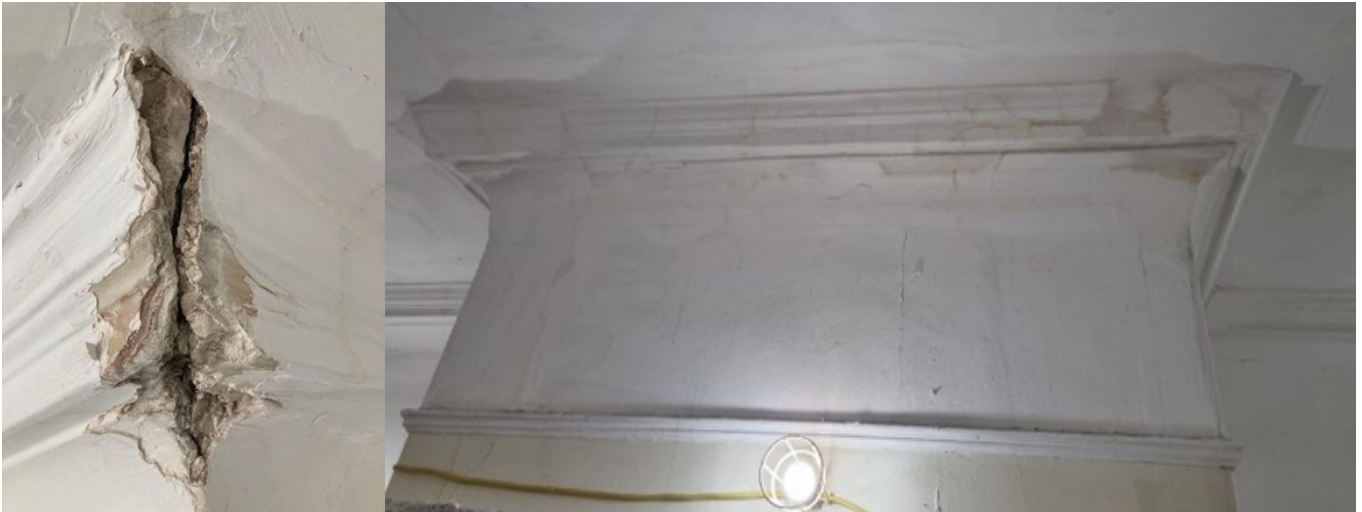
Left: Damage to junction of cornice over fireplace. Right: Patch repairs to plasterwork of chimneybreast.

In addition to addressing areas of dry rot, repairs were carried out where previous late 20th century partition walls had been removed. Scaring was most evident at the junction between these partitions and the historic plaster cornices. A comprehensive approach was taken with the three properties to include the repair of cracks, the replacement of missing enrichments and the removal of poorly executed previous repairs which all served to restore the historic plasterwork back to how it would have been in the 1830's.

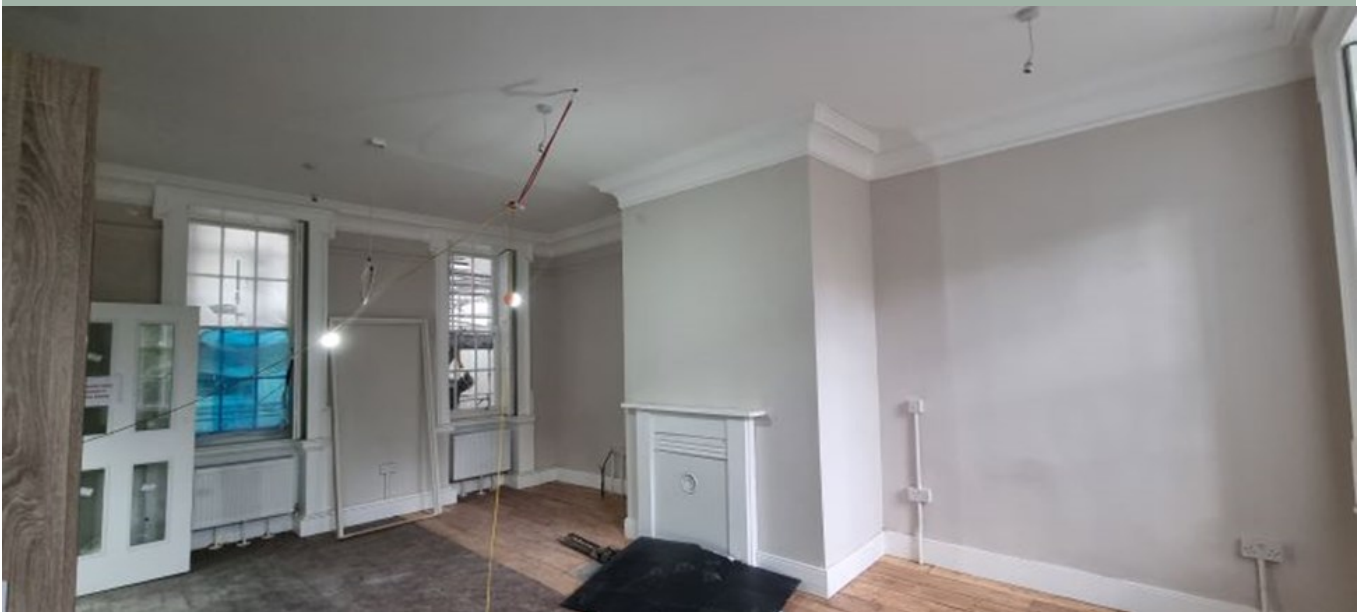
Completion of plaster conservation works to the Rubrics, Trinity College.

As with Wilton Place we saved as much of the historic plasterwork as possible however while all works were carried out to a high standard of repair, the approach taken was one of conservation over restoration. Missing sections of decorative plasterwork were

In a building over 300 years old there were a lot of 'humps and bumps'. Areas of historic damage were largely left untouched – offering a very honest approach to the works. Of course in some areas a different tact was taken due to specific circumstances in in these areas agreement was reached with the Design Team on a case-by-case basis. Large cracks in the decorative plasterwork were repaired but smaller cracks or incidentally chips etc. were not. In this instance the approach of the Design Team respects the 300 year historic of the building 'humps and bumps' and all!

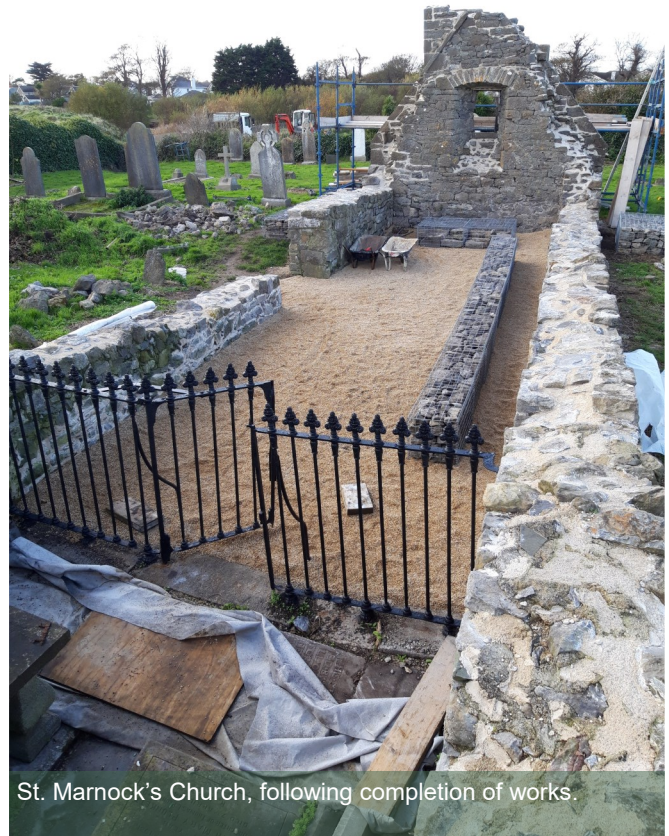
St. Marnock's Church, following completion of works.

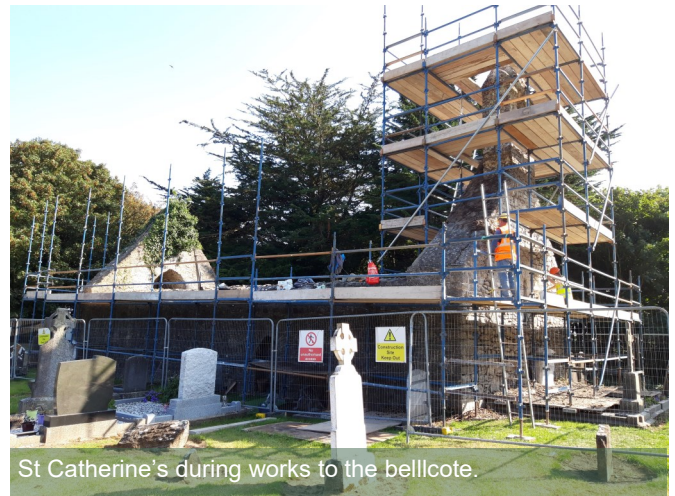
St Catherine's during works to the bellcote.
